Detailed Environmental Site Investigation

3-11 London Street

Lyttelton

15681.000.000_04

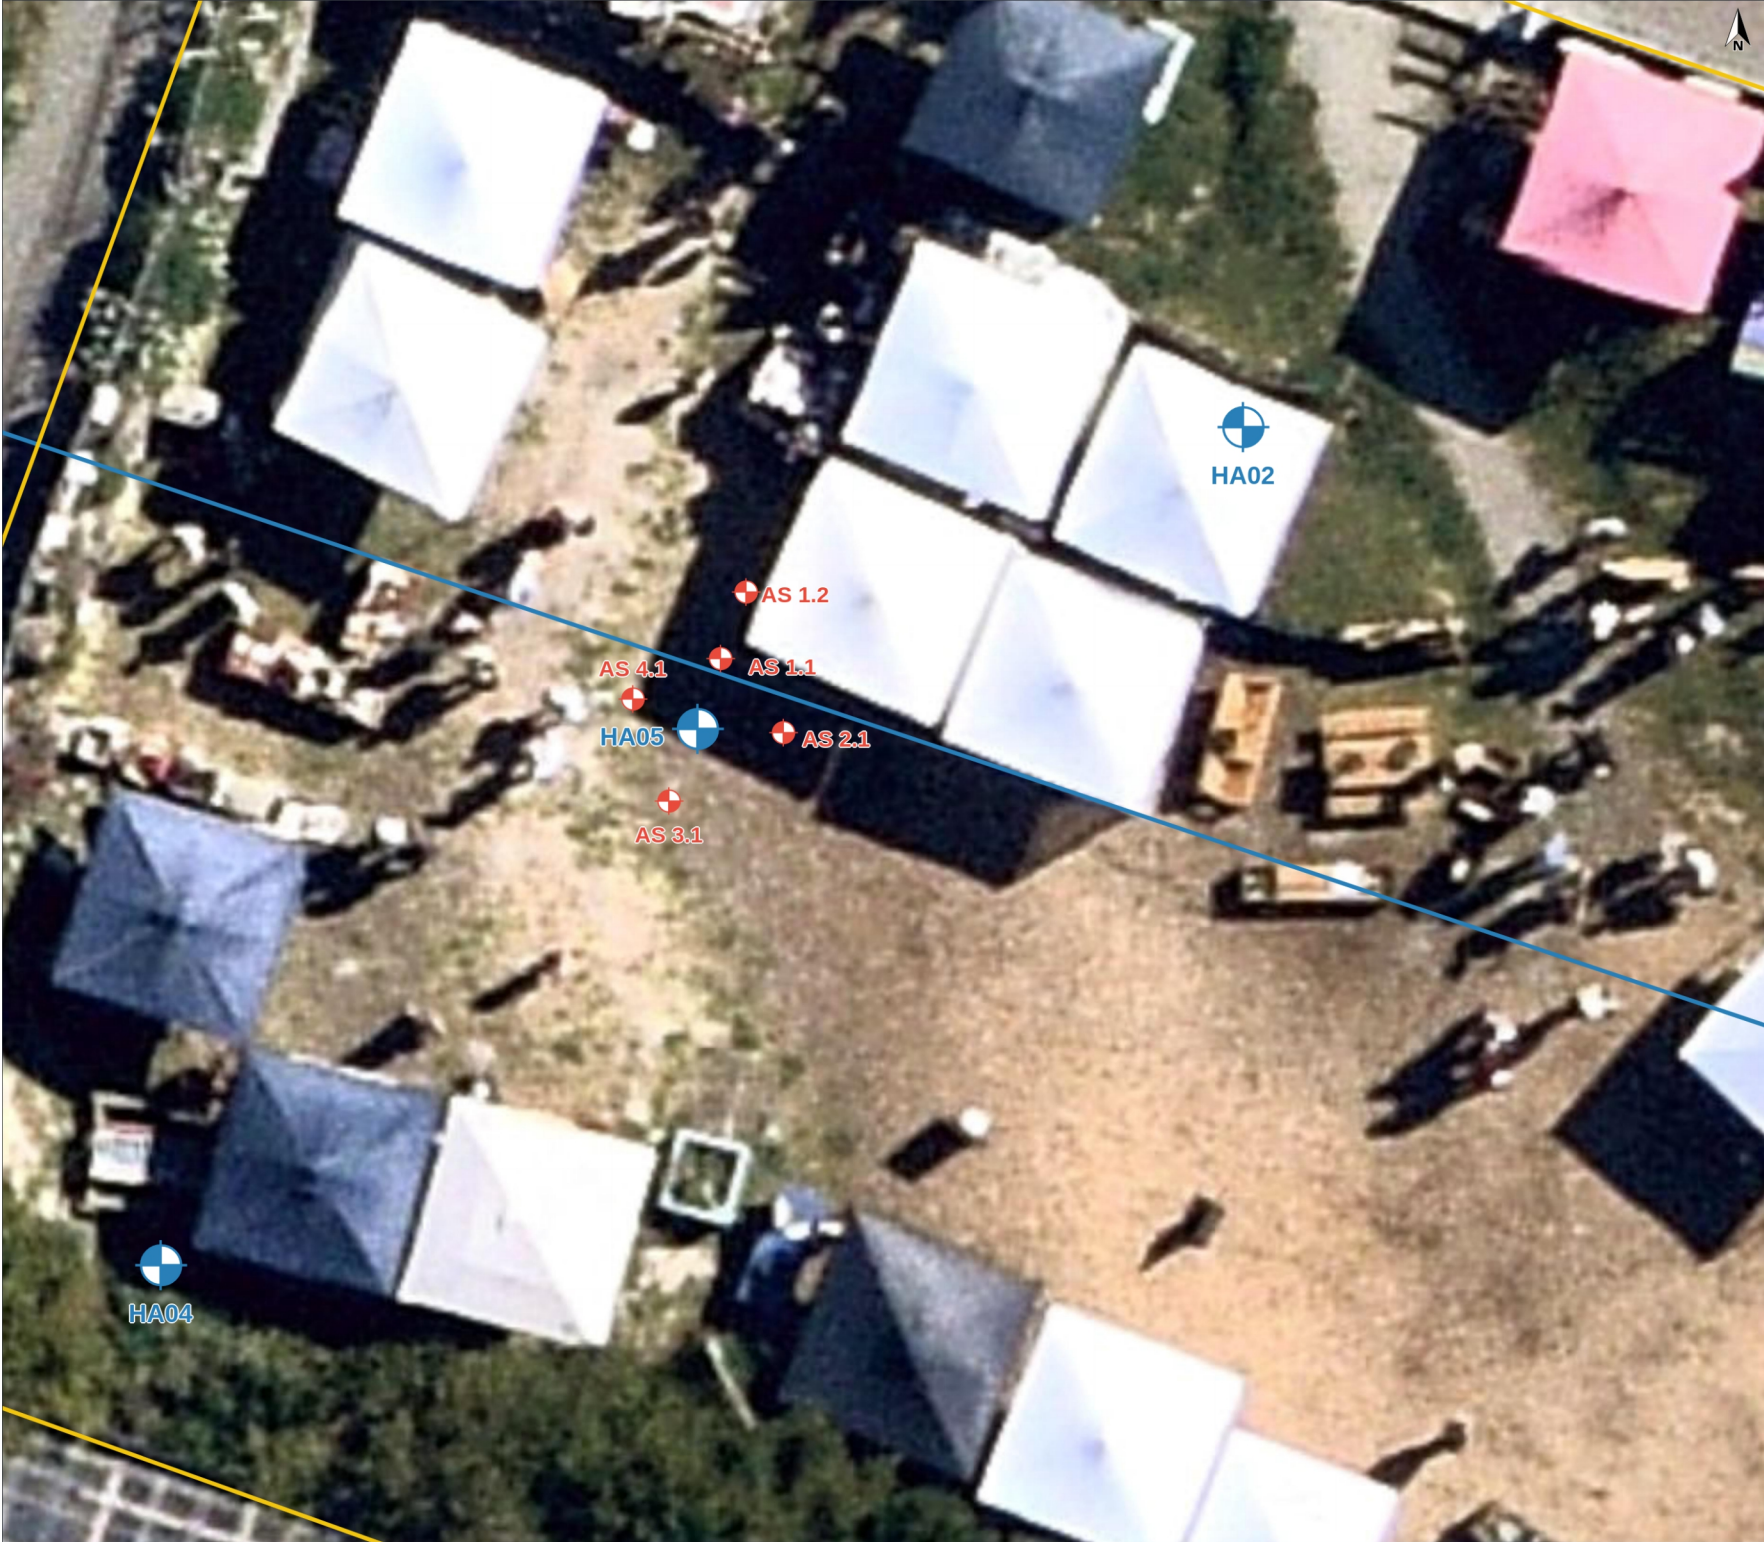
Client: Collet's Corner Limited		Figure No: 1
Project: 1 London Street	Drawn: LEG	
Date: 09-02-2021	Checked: NC	Size: A4
Proj No: 15681		Version: 1

- Legend**
- ▭ Site Boundary
 - ⊕ 2018 Hand Augers
 - ⊕ Delineation Sampling
 - polyline

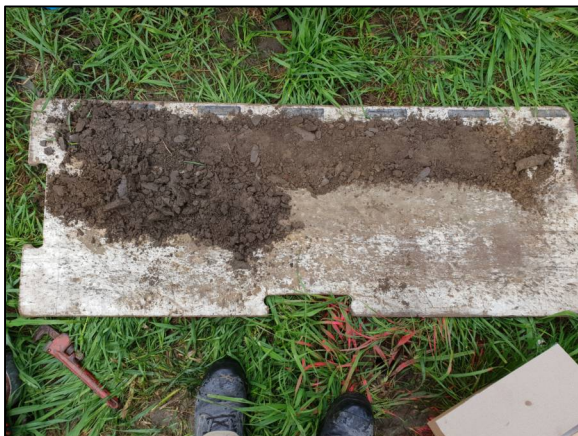
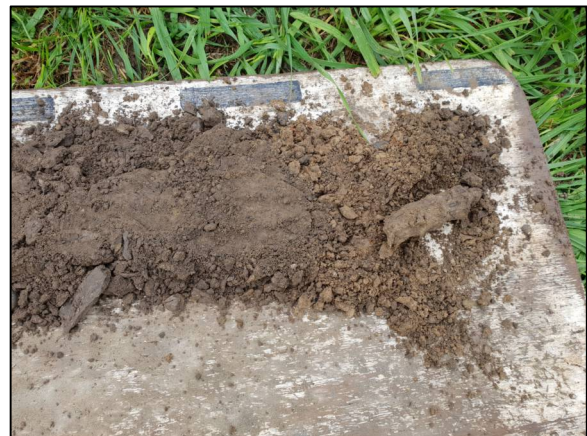
Depth (m)	Material	USCS Symbol	DESCRIPTION	Graphic Symbol	Water Level	Moisture Cond.	Sample	PID (ppm)
0.5		ML	SILT with trace brick, charcoal, sand and rootlets; brown. Low plasticity. [FILL]	[Cross-hatched pattern]			HA01	0
		ML	SILT with trace brick, charcoal and sand; brown. Low plasticity. [FILL]					
1.0		ML	Becomes yellowish brown from 0.9 m depth. Becomes brown from 1.1 m depth.					
1.5	End of Hole Depth: 1.5 m Termination Condition: Practical refusal							
2.0

Hand auger met practical refusal at 1.5 m depth on hard material.

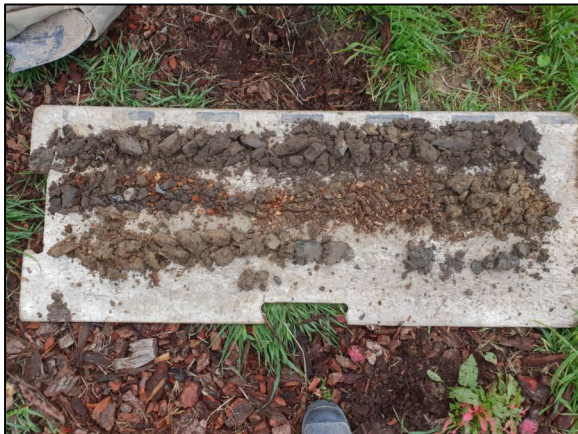
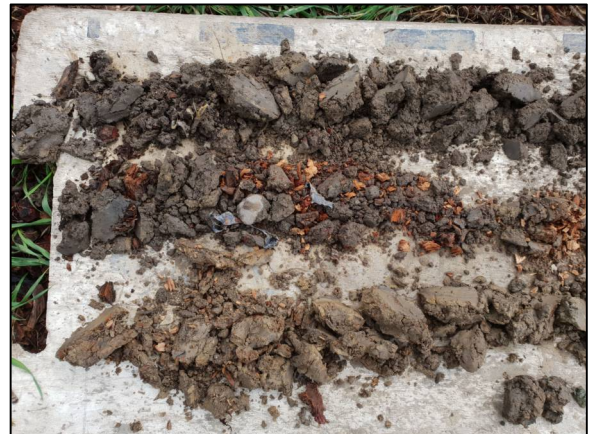
Depth (m)	Material	USCS Symbol	DESCRIPTION	Graphic Symbol	Water Level	Moisture Cond.	Sample	PID (ppm)
0.5		ML	SILT with trace brick, charcoal, plastic and rootlets; brown. Low plasticity. [FILL]				HA02	0
0.5			SILT with trace brick, charcoal and plastic; brown. Low plasticity. [FILL]					
1.0		ML	Major woodchips encountered from 1.0 m depth.					
2.0		ML	SILT with minor sand, trace charcoal and brick; yellowish brown. Low Plasticity. [FILL]					
2.5		ML	SILT with trace sand, charcoal and brick; bluish grey. Low plasticity [FILL]					
3.0			Purple colour encountered at 2.8 m depth.					
3.0	End of Hole Depth: 3 m Termination Condition: Practical refusal

Hand auger met practical refusal at 3 m depth on hard material.

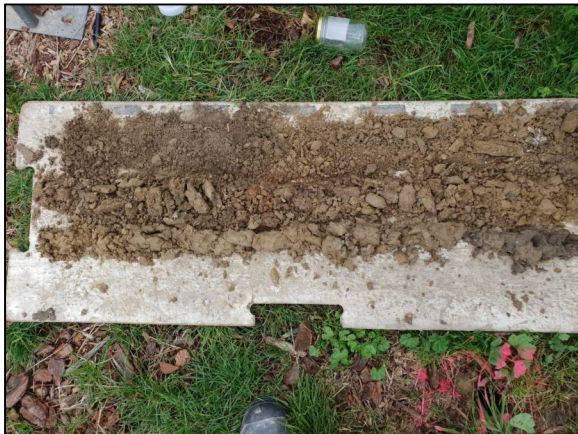
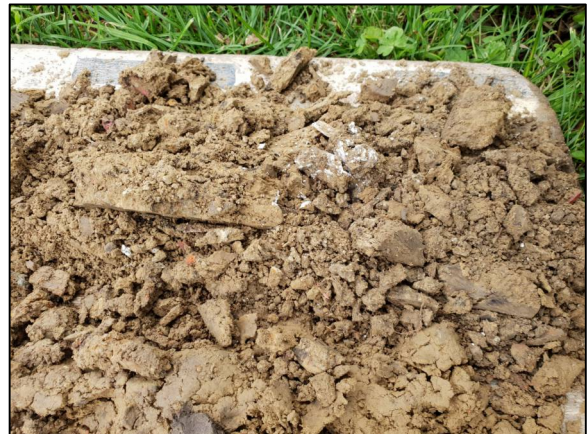
Depth (m)	Material	USCS Symbol	DESCRIPTION	Graphic Symbol	Water Level	Moisture Cond.	Sample	PID (ppm)
0.5		ML	SILT with minor sand, trace brick, charcoal and rootlets; brown. Low plasticity [FILL]	[Cross-hatched pattern]			HA03	0
			SILT with minor sand, trace brick and charcoal; yellowish brown. Low plasticity [FILL]					
		ML	White crystalline (unknown) substance encountered at 0.8 m depth. Trace wood encountered from 1.1 m depth Major brick, pottery and charcoal encountered at 1.3 m depth.					
		ML	SILT with major fine to medium sand; yellowish brown. Low plasticity. [FILL] Sand, poorly graded.					
3.0		ML	SILT with major fine to medium sand, trace charcoal and brick; black. Low plasticity. [FILL] Sand, poorly graded. End of Hole Depth: 3 m Termination Condition: Practical refusal

Hand auger met practical refusal at 3 m depth on hard material.

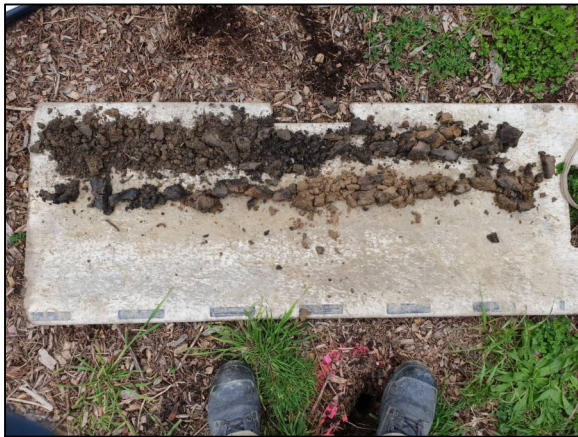
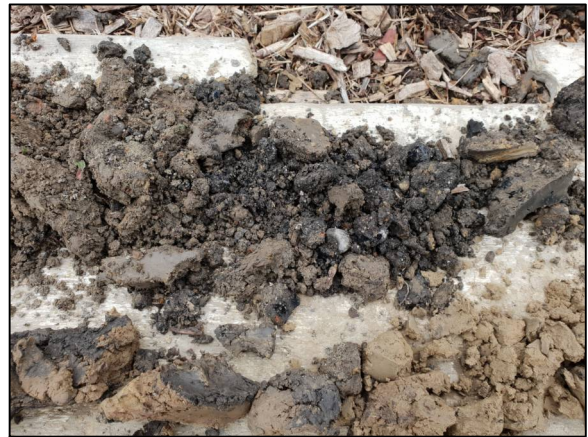
Depth (m)	Material	USCS Symbol	DESCRIPTION	Graphic Symbol	Water Level	Moisture Cond.	Sample	PID (ppm)
0.5		ML	SILT with trace brick and rootlets; brown. Low plasticity [FILL].	[Cross-hatched pattern]			HA04	0
		N/A	Ash layer encountered from 0.5 - 0.6 m depth.					
		ML	SILT with trace brick and charcoal; black. Low plasticity [FILL].					
		ML	SILT with some fine to coarse sand; yellowish brown. Low plasticity. Sand, well graded. [FILL]					
2.0			End of Hole Depth: 2 m Termination Condition: Practical refusal

Hand auger met practical refusal at 2 m depth on hard material.

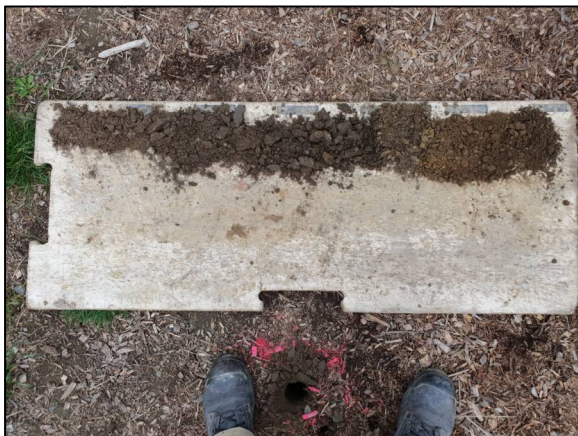
Depth (m)	Material	USCS Symbol	DESCRIPTION	Graphic Symbol	Water Level	Moisture Cond.	Sample	PID (ppm)
0.5		ML	SILT with trace sand, gravel, brick and charcoal; brown. Low plasticity. [FILL]				HA05	0
		ML	SILT with minor sand, gravel, brick and charcoal; yellowish brown. Low plasticity [FILL].					
1.0	End of Hole Depth: 0.9 m Termination Condition: Practical refusal							
1.5								
2.0

Hand auger met practical refusal at 0.9 m depth on inferred gravel.

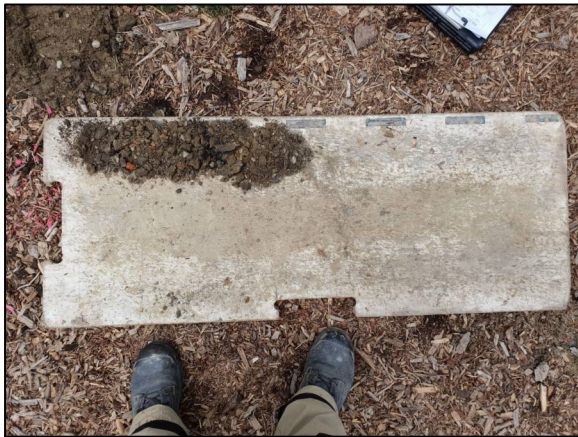
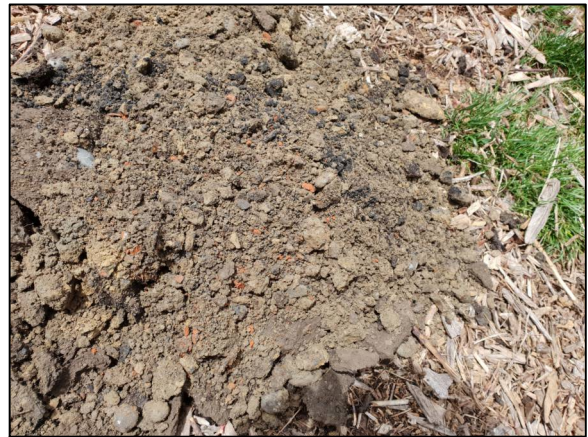
Depth (m)	Material	USCS Symbol	DESCRIPTION	Graphic Symbol	Water Level	Moisture Cond.	Sample	PID (ppm)	
0.5			SILT with trace brick, gravel, glass, terracotta and charcoal; brown. Low plasticity [FILL] Trace ash encountered at 0.5 m depth.				HA06	0	
			End of Hole Depth: 0.6 m Termination Condition: Practical refusal

Hand auger met practical refusal at 0.6 m depth on hard material.
